CALSPAN ON-SITE AIR BAG DEPLOYMENT INVESTIGATION

CALSPAN CASE NO. 93-15

VEHICLE - 1992 FORD TAURUS

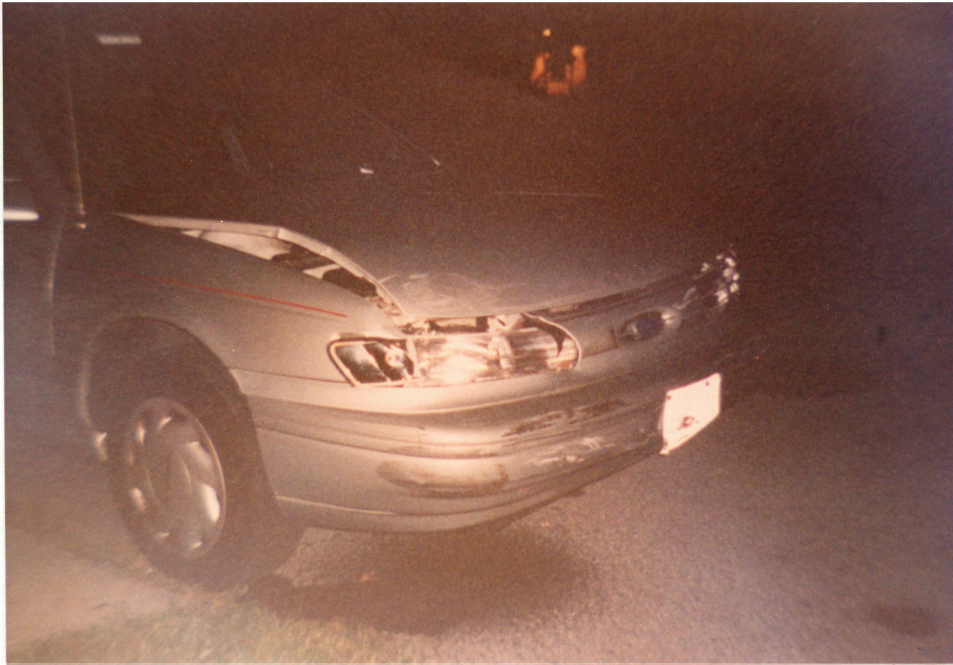
The full frontal area of the Ford Taurus impacted the right side area of the left turning vehicle #2. The Taurus sustained moderate frontal damage that was distributed across the full width of the vehicle. Based on impact configuration, resultant directions of force were probably within the 12 o'clock sector the Ford Taurus and within the # o'clock sector for the struck vehicle #2. As a result of the crash, the Taurus underwent a sufficient longitudinal deceleration which deployed the dual air bag SRS. The velocity change was estimated at 18-21 KPH (11-13 mph).

Frontal Damage To The Ford Taurus

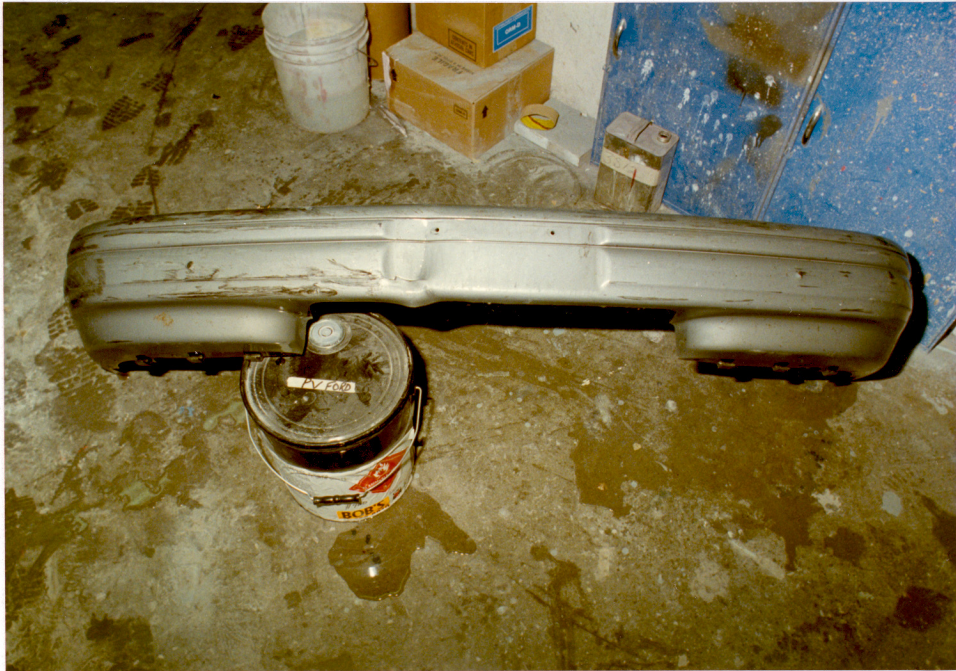
Damaged Bumper Facia

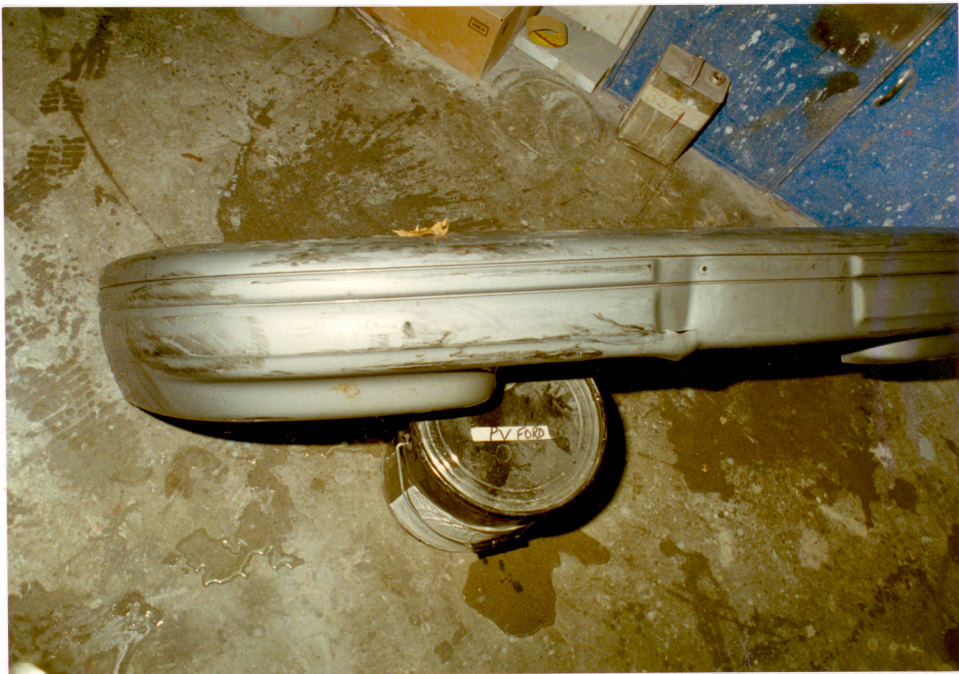
Direct Contact Damage To Right Side Of Bumper Facia

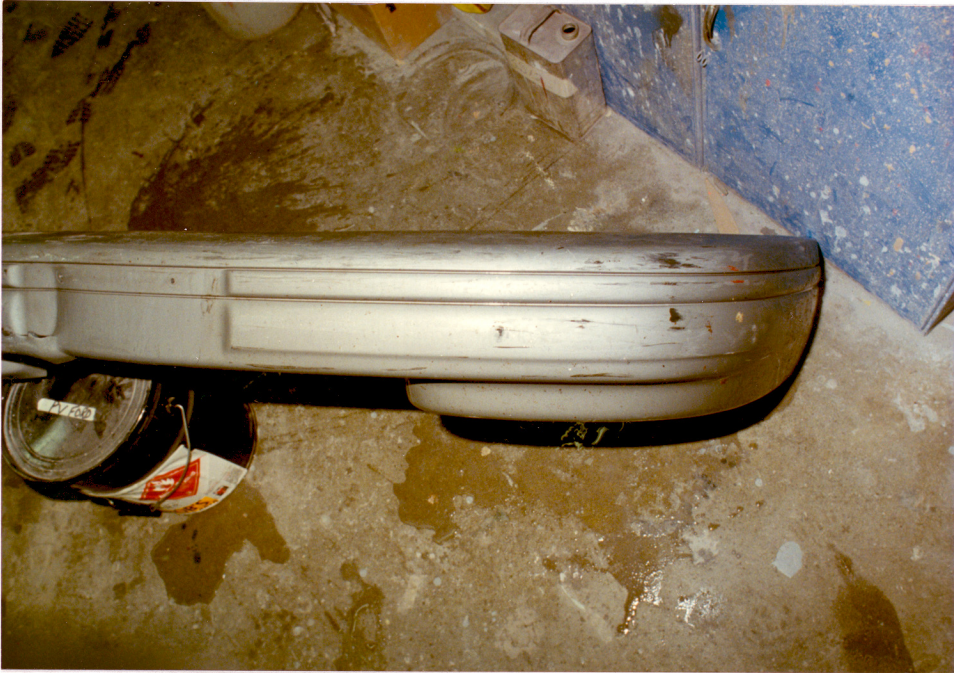
Direct Contact Damage To Left Side Of Bumper Facia

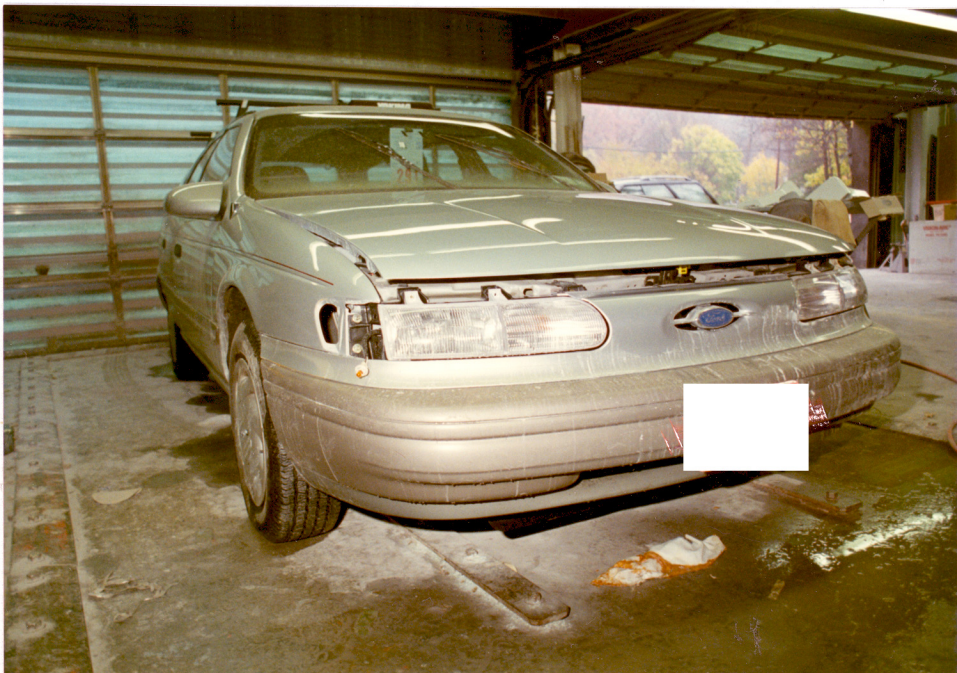
At the time of our inspection, the exterior damage to the Ford Taurus had been repaired. The body shop reported that they had replaced the front bumper, both bumper energy absorbing units (EADs), the header panel, hood, and the air conditioning condenser. In addition, the body shop repaired the right front fender and straightened the radiator support panel and both front frame rails. They also replaced the front mounted crash sensors for the SRS. The total repair cost was \$5,783.

Frontal View Of The Repaired Ford Taurus

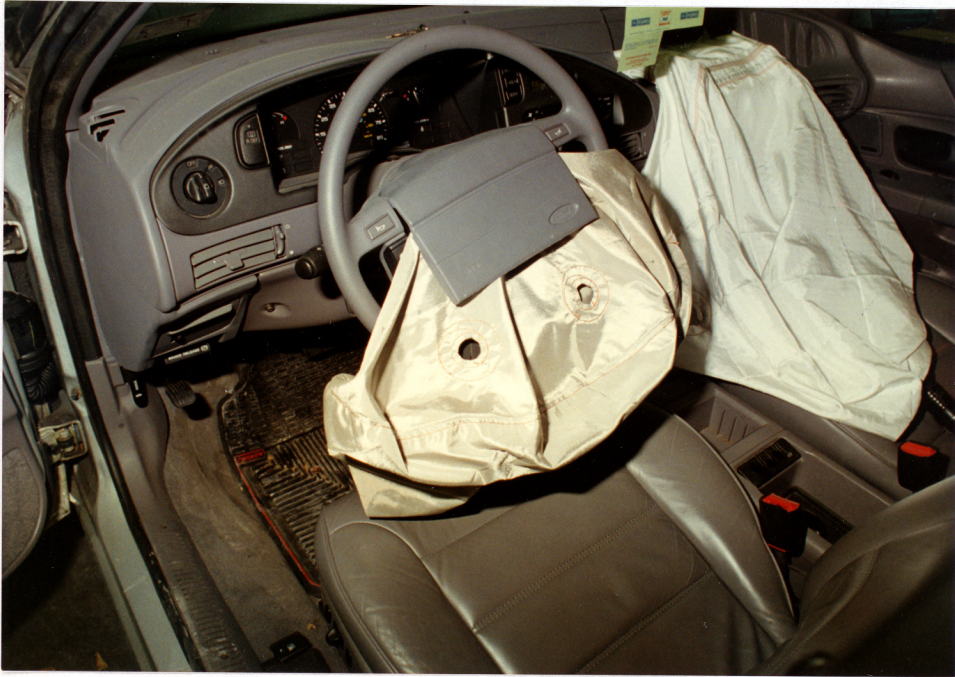
The driver's side air bag system deployed in a typical sequence from the steering wheel mounted module assembly. The module was contained within an offset (vertical orientation) four-spoke steering wheel rim with the cruise control buttons located on each side of the module. The module cover flap opened at the designated tear points in an H-configuration. The large upper flap measured 20.3 cm (8") horizontally x 12.4 cm (4.8") vertically while the smaller lower flap had respective measurements of 20.3 cm (8") x 3.5 cm (1.375"). Both cover flaps were approximately 8mm (5/16") in thickness. The upper module cover flap had an identification number [REDACTED] molded into the inside surface. There was no damage to the flaps.

Driver's Side Air Bag Vent Ports And Upper Module Cover Flap

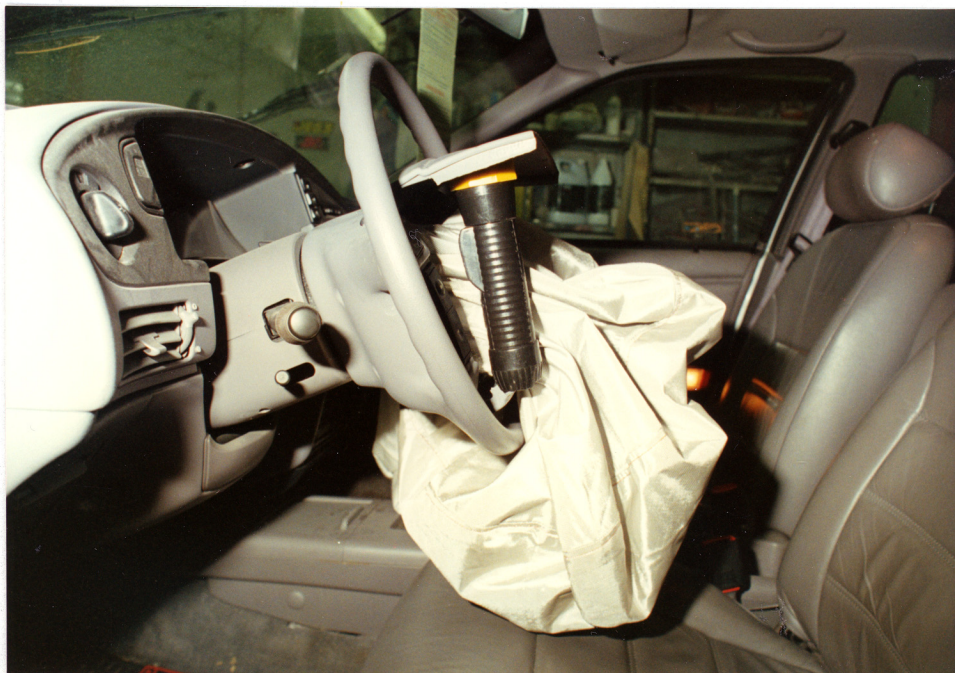
Perpendicular View Of The Driver's Side Module Cover Flaps

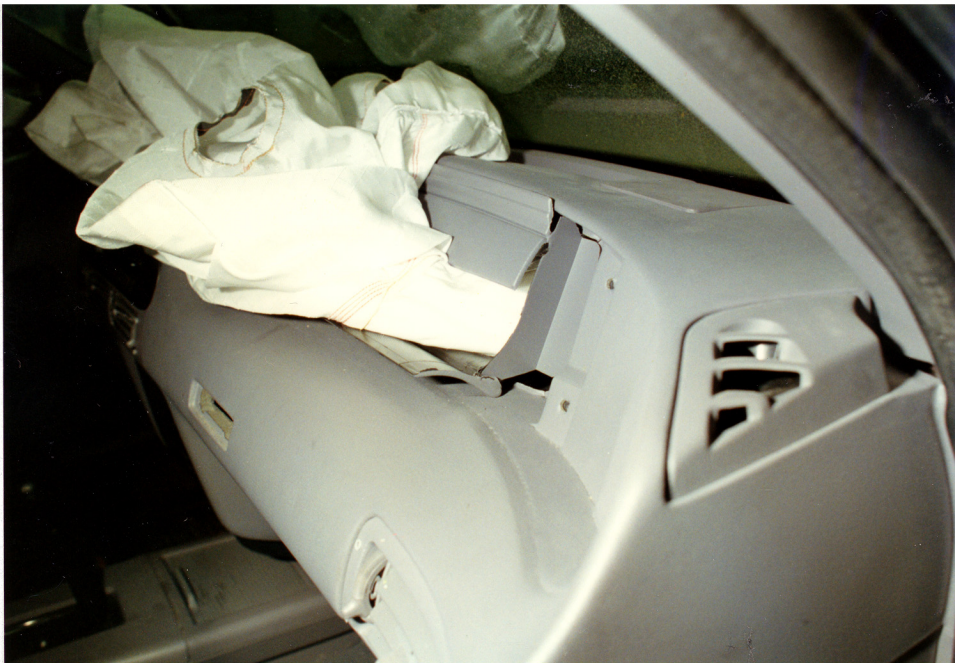
The passenger side air bag deployed from the module that was mounted into the upper right instrument panel of the Ford Taurus. The module cover flaps were positioned in a vertical orientation and opened in an H-configuration. The upper flap was rigid and remained in a vertically orientated (closed) position. The flap was 31.1 cm (12 5/16") wide and varied in height, 7.5 cm (2 15/16") at the left edge, 7 cm (2.75") at the center, and 6 cm (2 3/8") at the right edge. The lower module cover flap was hinged at the bottom and opened fully to 90 degrees. The flap was similar in width to the upper and was 6.5 cm (2.5") in height at the edges and 6.7 cm (2 5/8") at the center point. Both module cover flaps were approximately 3 mm (1/8") in thickness.

Perpendicular View Of The Passenger Side Air Bag Module Cover Flap

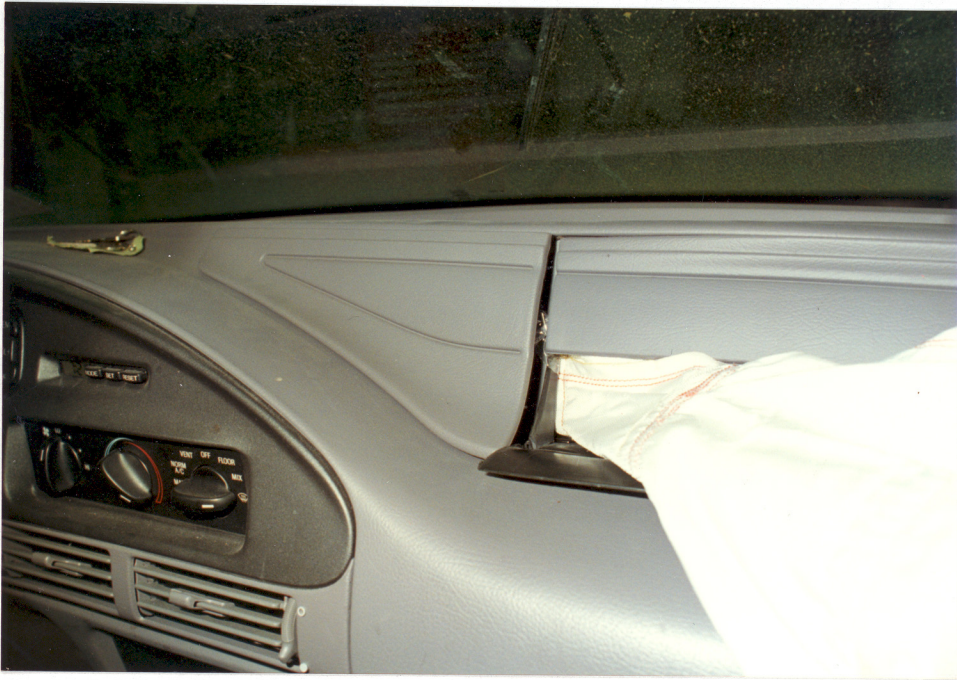
Both trim panels appeared to have been dislodged by the module cover flaps as the passenger side air bag deployed. The three spring clips for the left side trim panel had disengaged from their mounting holes and the panel was found resting on the upper/mid instrument panel juncture. The right side trim panel had completely separated from the instrument panel and was found by the driver and her husband on the right front floor, adjacent to the outboard corner of the bucket seat cushion. In addition to the separation of the trim panels, a small rigid plastic TAURUS name plate disengaged from the right mid instrument panel located between the glove box door and the passenger air bag module assembly. The 9 cm (3 1/2") x 2 cm (13/16") name plate came to rest on the right front floor area of the vehicle.

Disengaged Trim Panel Adjacent To The Left Side Of The Passenger Air Bag Module

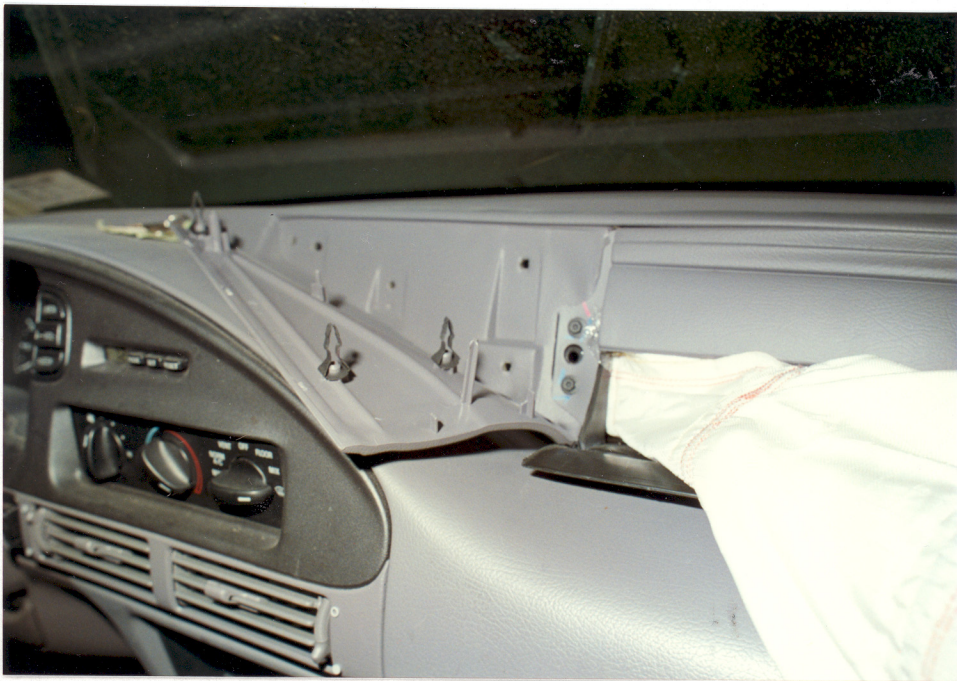
Spring Clips And Mounting Holes

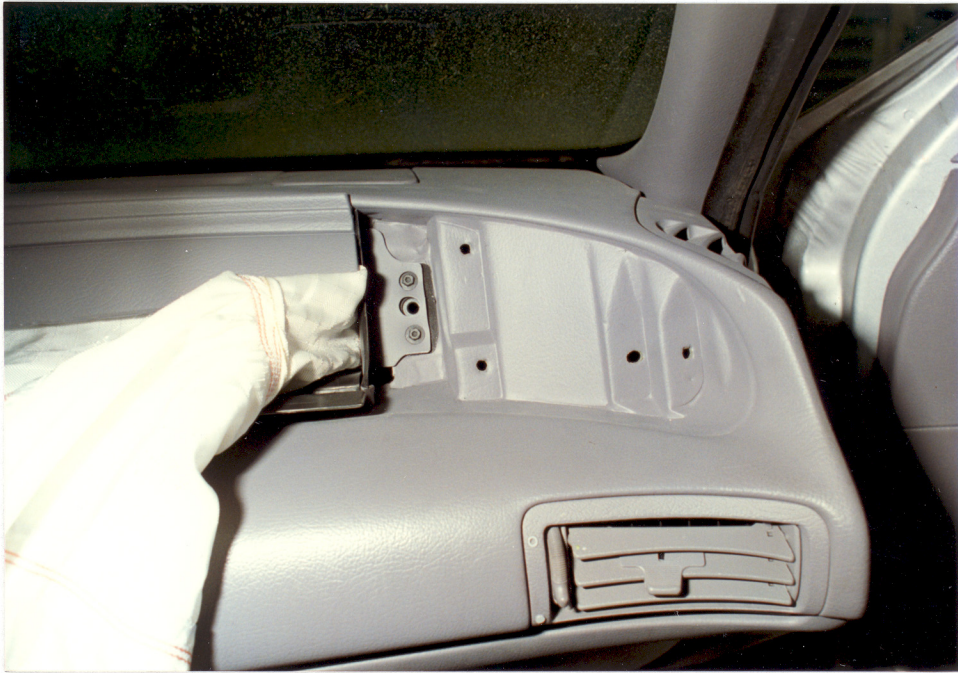
Disengaged Right Side Trim Panel

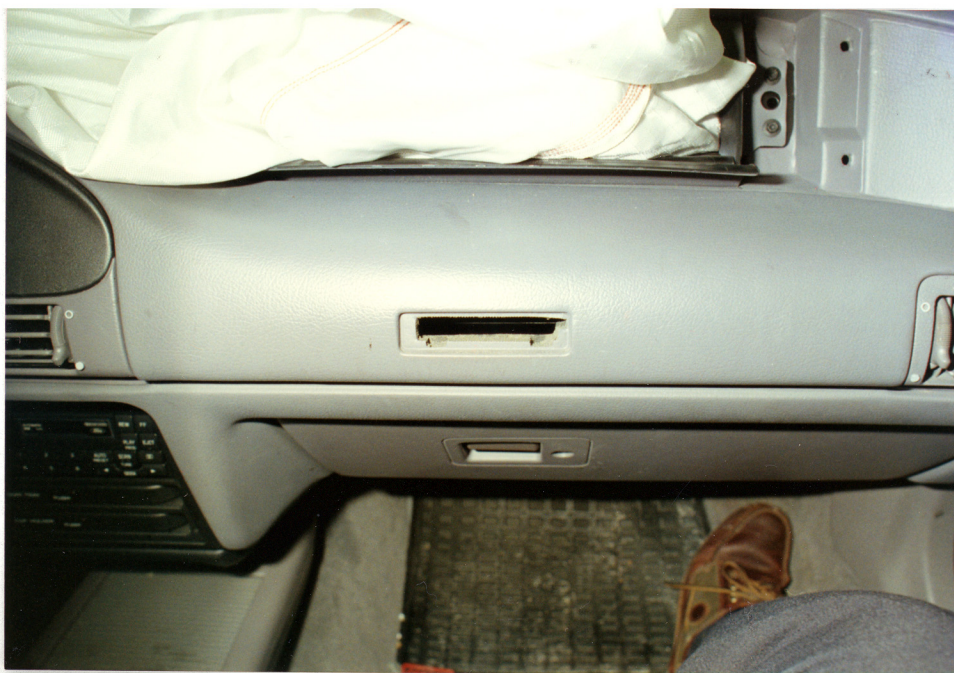
Disengaged TAURUS Name Plate From Mid Panel

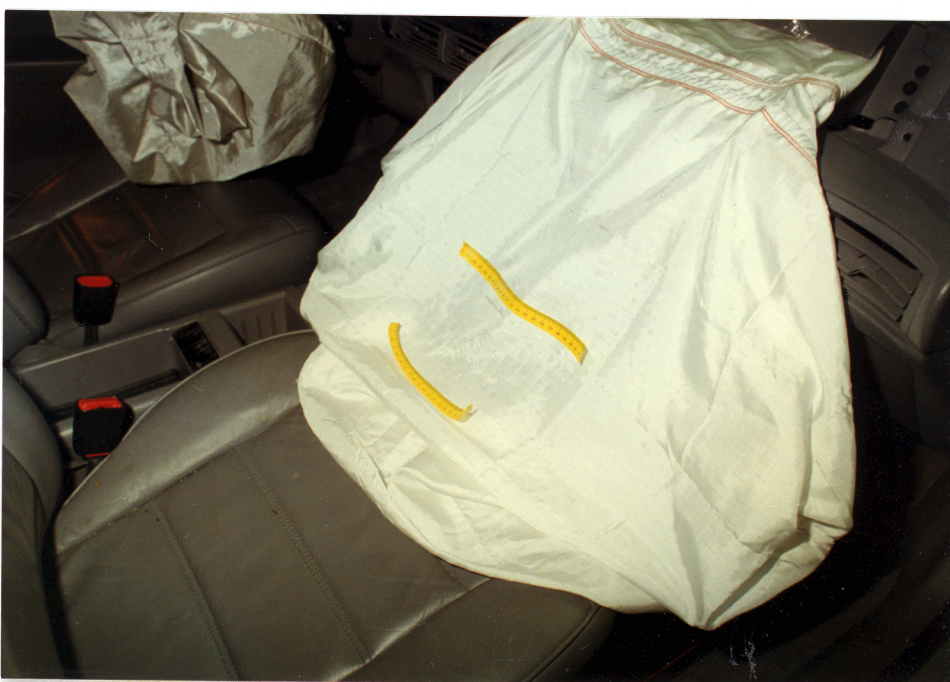
Fabric Snags In Passenger Side Air Bag

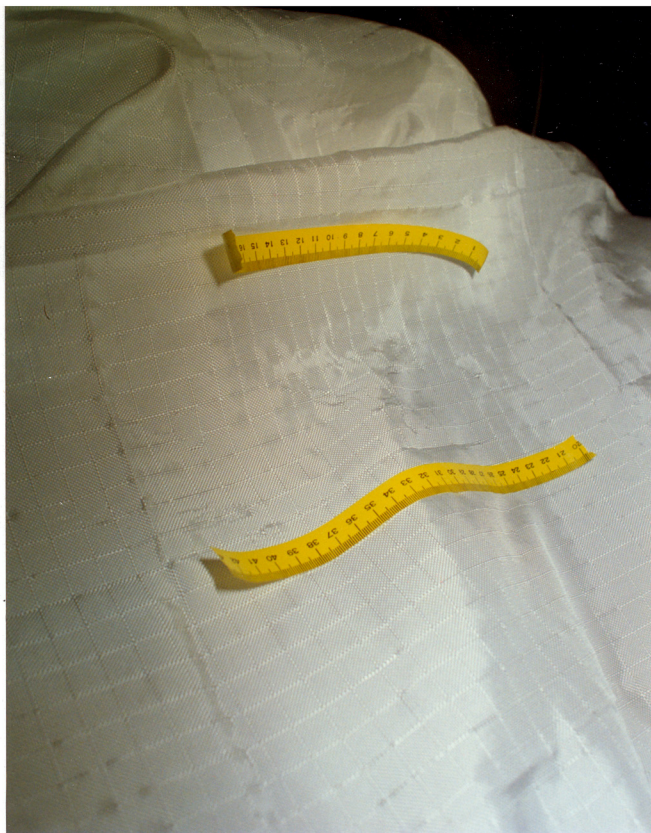
Closeup View Of The Fabric Snags
